# REPORT OF INTERIOR SURVEY AIRBUS A321, P4-NAS, P4-OAS OPERATED BY AIR ASTANA

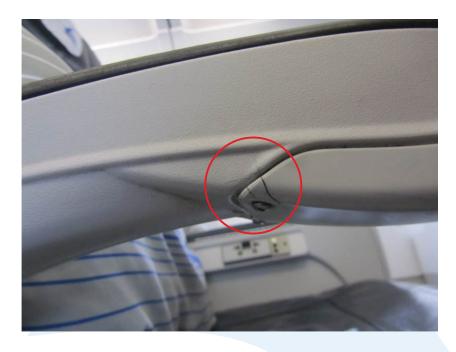
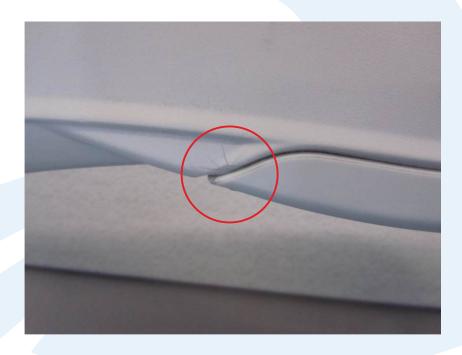
## 1.1 Armrest shrouds and escutcheons

Description: cracks in attaching points

Recommendation: Replacement of parts.

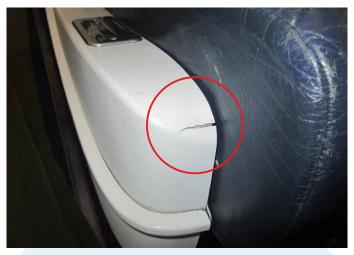
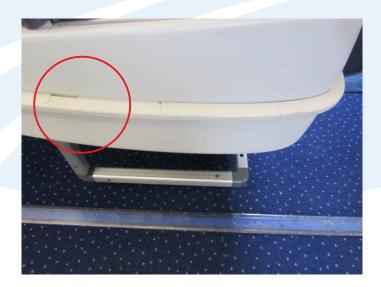
## 1.2 Seat bumpers and strips

**Description:** cracks and damages

Recommendation: Replacement of parts.

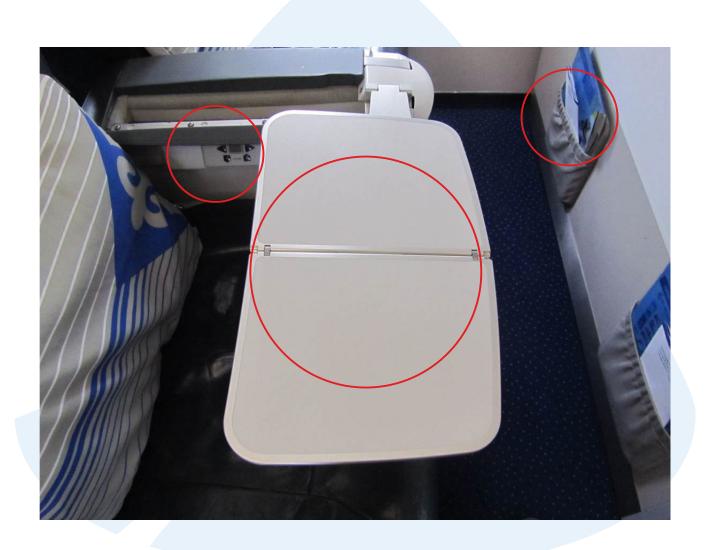
## 1.3 In-arm tray table, DPCU, lit. pocket

**Description:** Parts in good condition.

Recommendation: DPCU could be deactivated via customized cover if system is inactive.

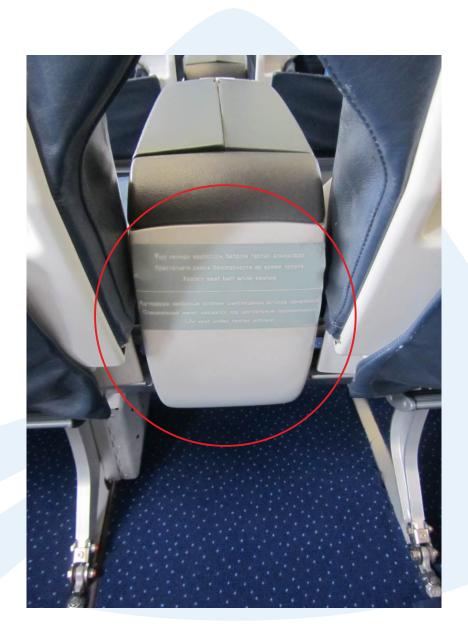
## 1.4 Placards

Description: Damages, detachment.

Recommendation: Placards shall be replaced.

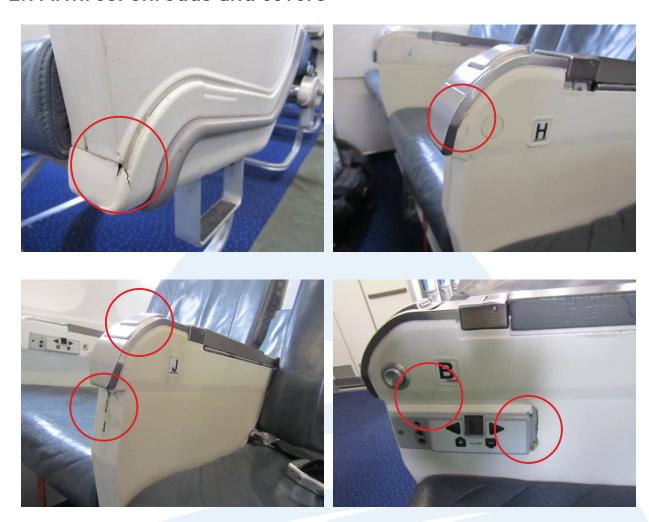
### 2.1 Armrest shrouds and covers

Description: Damages, cracks, broken covers

Recommendation: Replacement of parts, DPCU could be deactivated via customized cover if system is inactive. Ashtrays could be deactivated by covers.

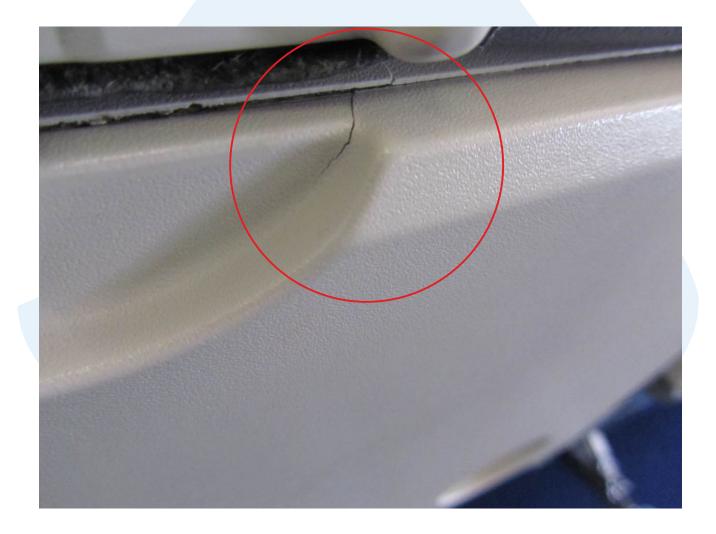
## 2.3 Tray tables and in-arm tray tables, latches

**Description:** Damages, cracks.

Recommendation: Replacement of parts.
